First Five-Year Review Report  
for  
Parker Landfill Superfund Site  
Town of Lyndonville  
Caledonia County, Vermont

September 2004

United States Environmental Protection Agency  
Region 1  
Boston, Massachusetts

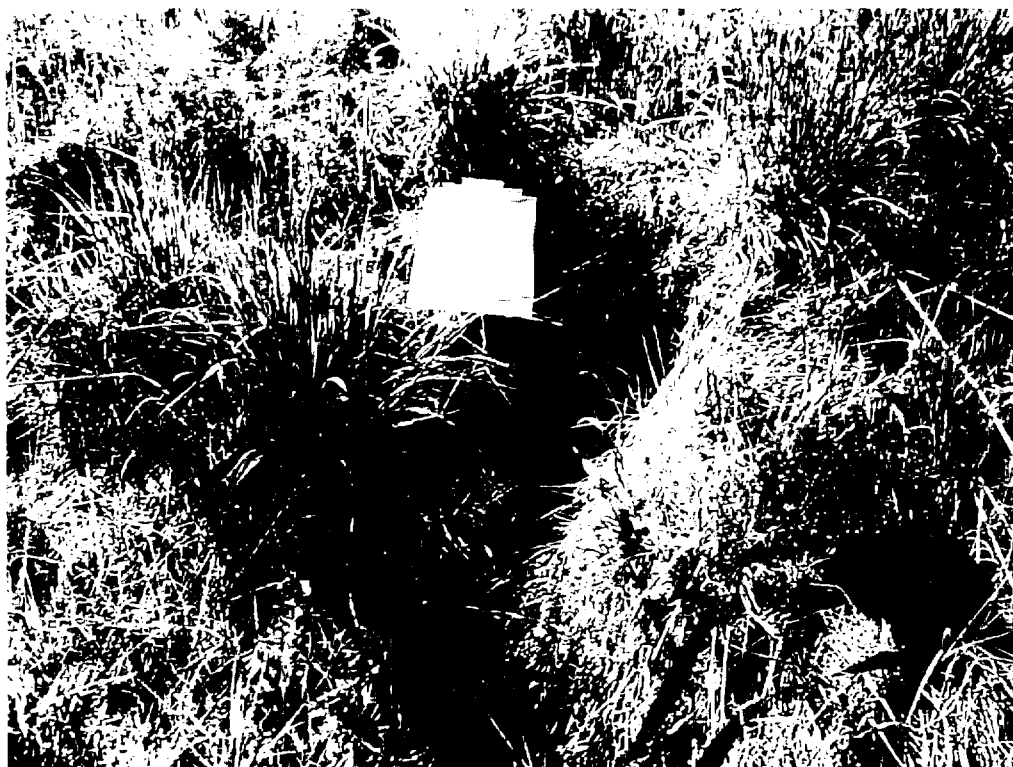
An apparent animal burrow and associated erosion rill were observed on the steep embankment below and to the north of the IWS-3 cap (Photo 4). The animal should be removed and the hole and erosion repaired in order to prevent possible undermining of the IWS-3 cap.

Photo 4 Hole and Erosion Below IWS-3 Cap

- Fill in the burrow hole and repair the erosion on the steep embankment below the IWS-3 cap;
- Repair the erosion and take steps to prevent further erosion of the access road leading from the SWDA to IWS-3.
- Monitor the settlement of Downcomer No. 2 and investigate/repair if the functionality of the downcomer or the integrity of the cap is threatened;
- Monitor the gas extraction wells and institute measures to prevent the gas extraction wellheads from freezing if the performance of the landfill gas system is impaired.
- Raise the weir structure of the Wetland Compensation area to increase the water level to encourage additional habitat usage.

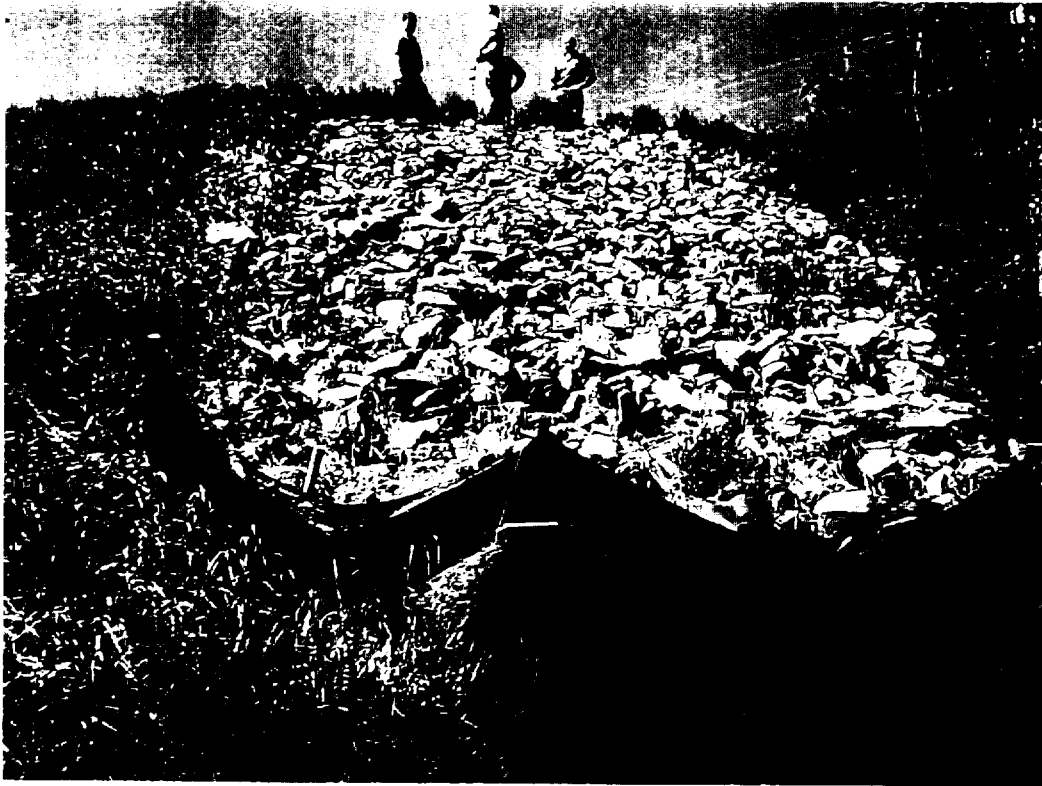
An area of erosion located just below the edge of the cap at the northeastern corner of the SWDA landfill was observed during the Spring and Fall 2002 inspections. Rip rap had been placed over the area in order to stabilize the erosion in 2003. This area was checked for indications of recent erosion. The rip rap appeared to be stable and no further erosion was observed (Photo 5).

Photo 5 Rip Rap Repair of Erosion at Northeast Corner of Landfill.

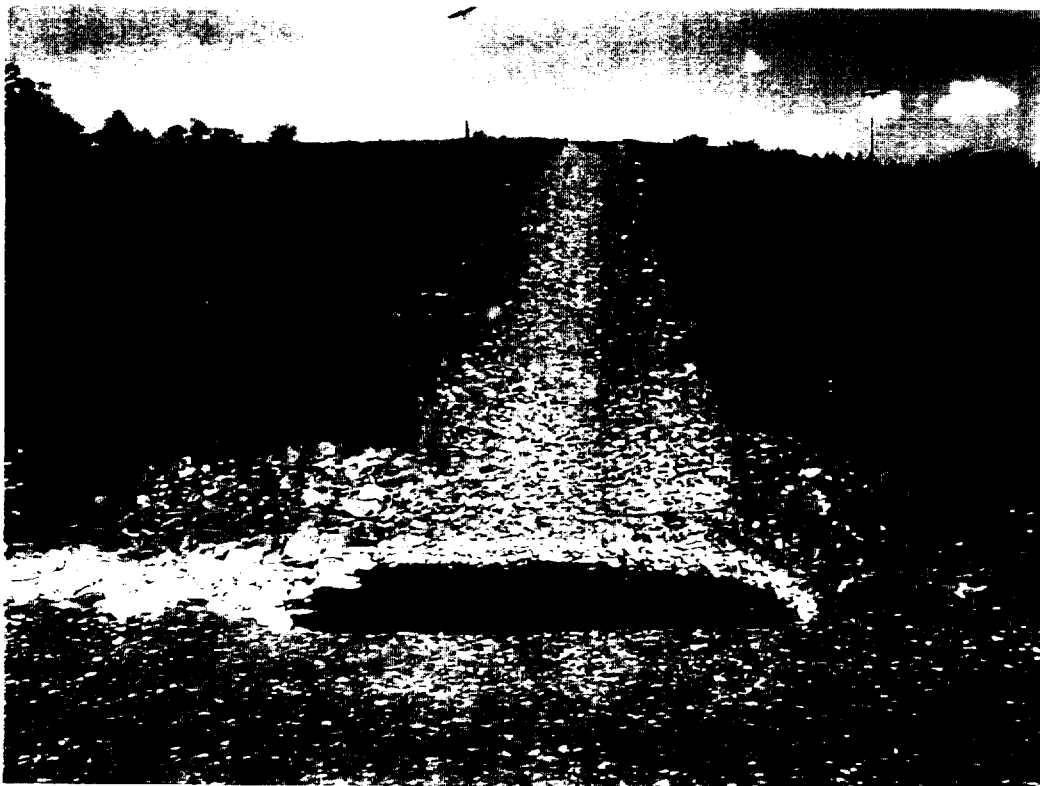
The two gabion-lined downcomers, or letdown channels, were inspected for settlement, material degradation, erosion, undercutting, obstructions and vegetative growth. Downcomer #1 was in good condition at the time of the inspection (Photos 6).

Photo 6 Downcomer No.1 on the East Slope of Landfill Looking West.

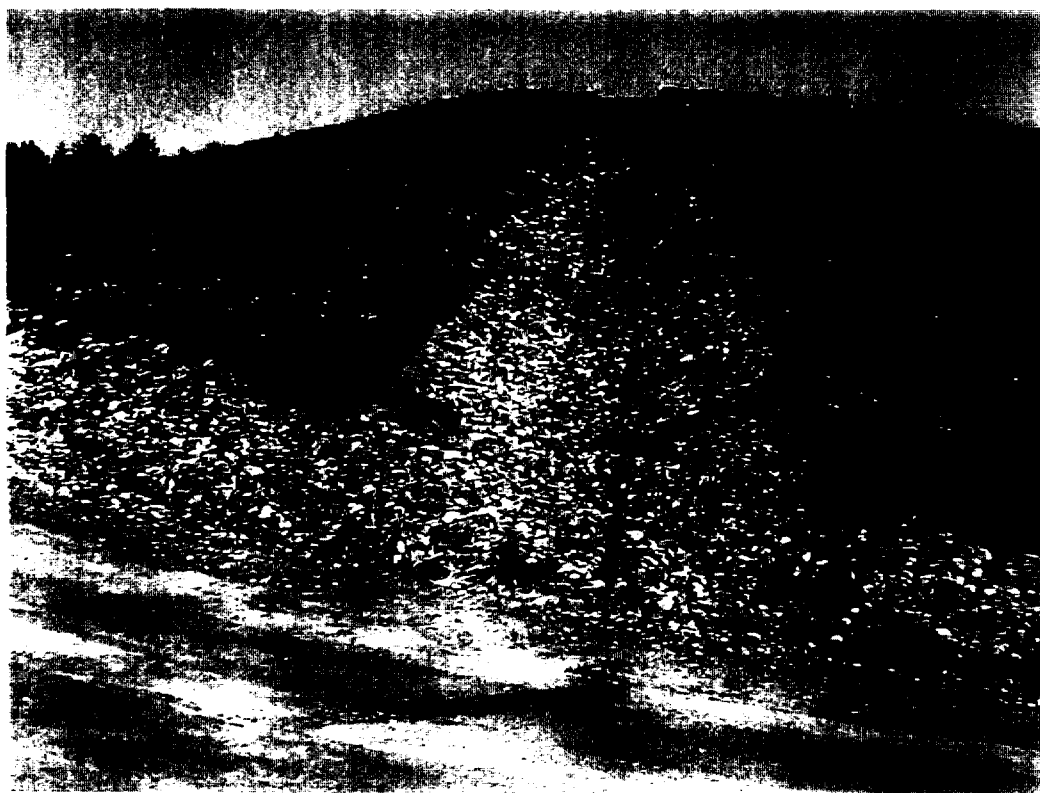
Downcomer #2 was in good condition with the exception of an area of what appeared to be settlement of the gabions in the bottom of the channel between the first and second slope benches from the perimeter ditch (Photo 7). The bottom gabions appeared to have settled approximately six inches when compared to surrounding gabions (Photo 8). The cause of the settlement was not apparent at the time of the inspection. TRC recommends close monitoring of the settlement over the next year so that repairs can be made in a timely manner if the functionality of the downcomer is impaired, or the integrity of the cap is threatened. Particular attention should be given to evidence of erosion or undercutting beneath the gabions. If left uncorrected, significant erosion could expose or damage the drainage layer and geomembrane liner of the cap system.

Photo 7 Downcomer No.2 Looking North.

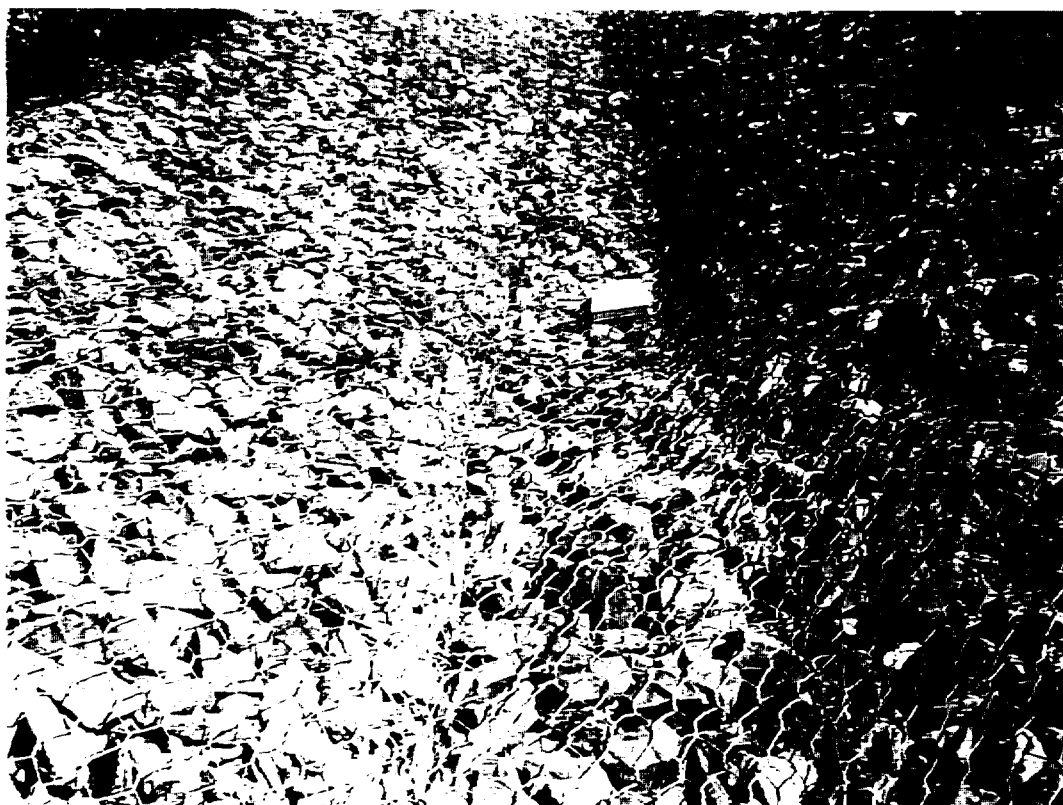
Photo 8 Settlement in Downcomer No. 2

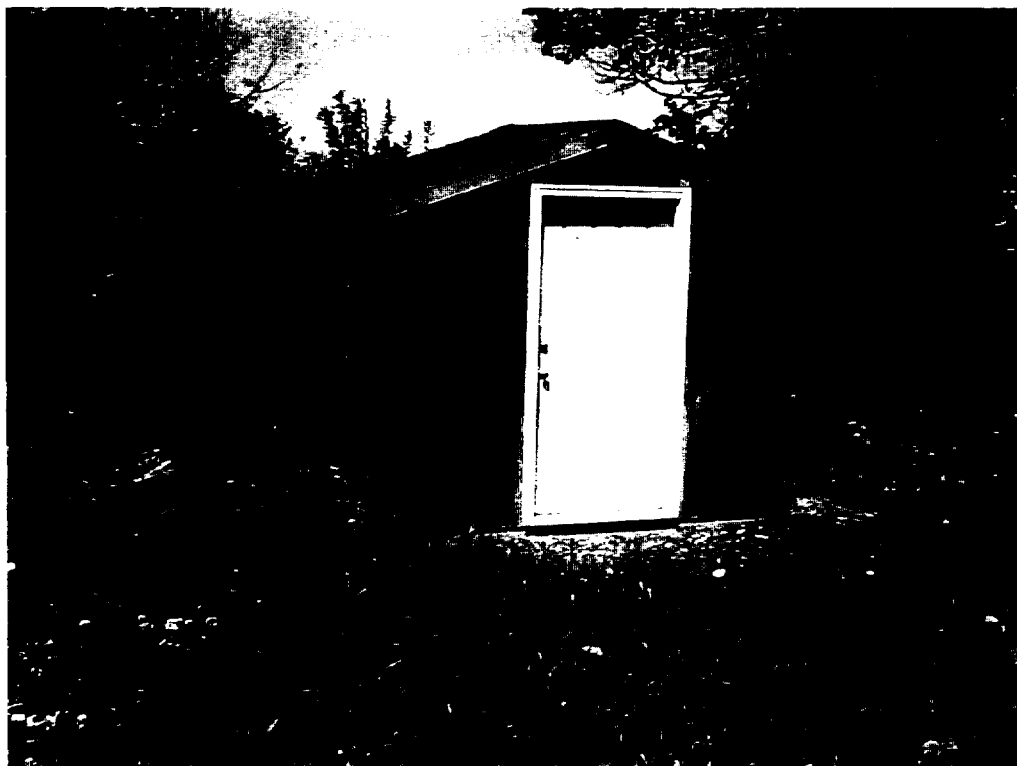
The shed constructed to house the gas sensor data logger and alarm system components was inspected and found in good condition (Photo 10). According to representatives of Fairbanks Scales, the gas monitoring system does not operate properly and has not been used for subsurface gas monitoring. The electronic signal transmitted from the gas sensors in the gas probes to the data-logging/alarm system in the shed has been observed by Fairbanks in the past to fluctuate erratically and has not been consistent with measurements of gas concentrations using hand-held instruments. The cause of the malfunction is unknown. The landfill gas monitoring and data logging system remains inactive due to concerns regarding the accuracy of the system. The PRP is currently hand

Photo 10 Gas Monitoring System Shed.

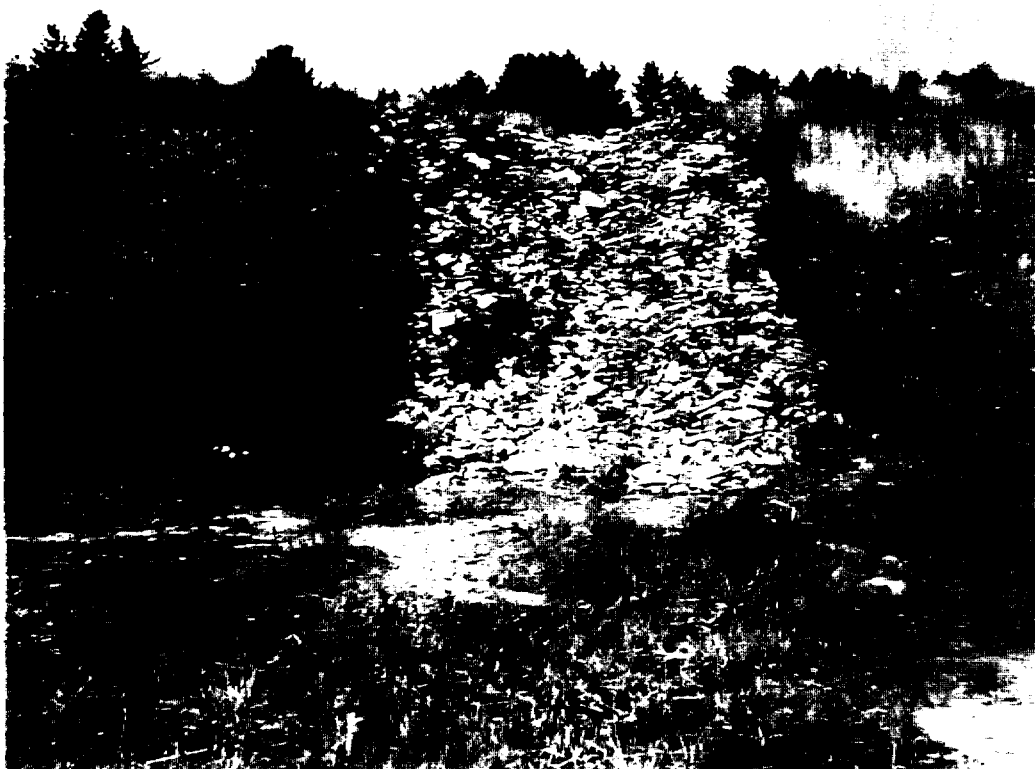
The sedimentation basin is in good condition and appears to be functioning properly. Two rip rap-lined drainage structures (downcomers) located on the southern and western sidewall of the sedimentation basin (Photos 12, 13, and 14) had been damaged in 2002 by undercutting erosion. Both downcomers were repaired. No further erosion was observed.

Photo 12      Rip Rap Downcomer – West Sidewall of Sedimentation Basin.

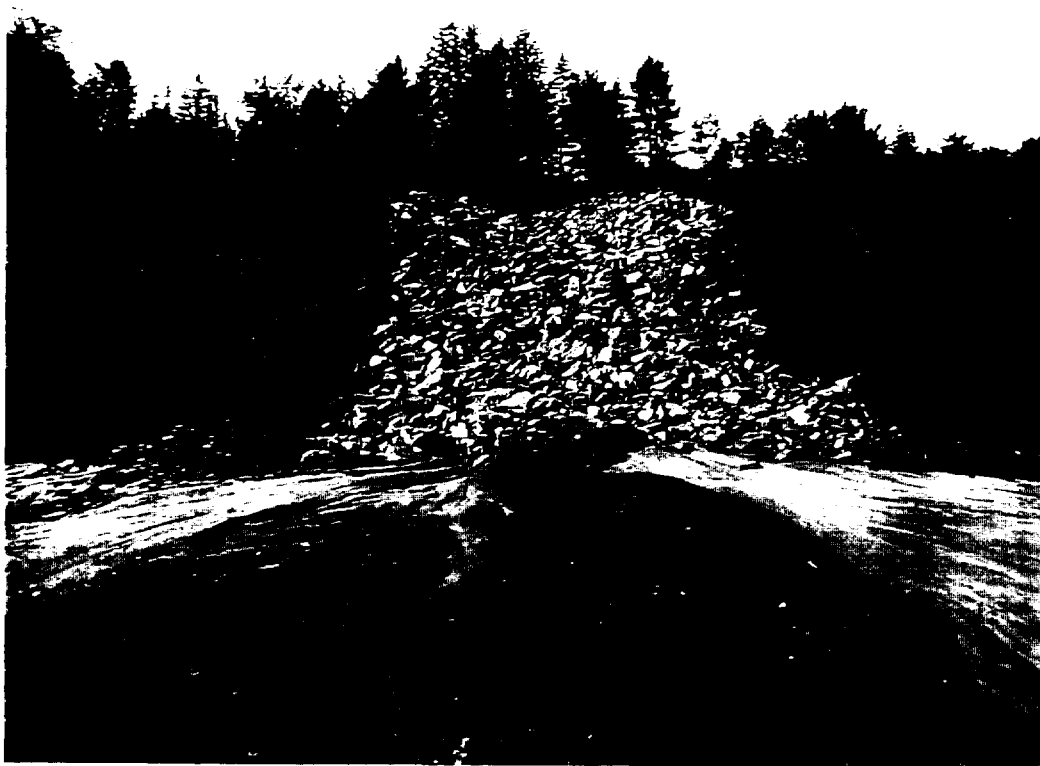
Photo 13 Rip Rap Downcomer – South Sidewall of Sedimentation Basin.

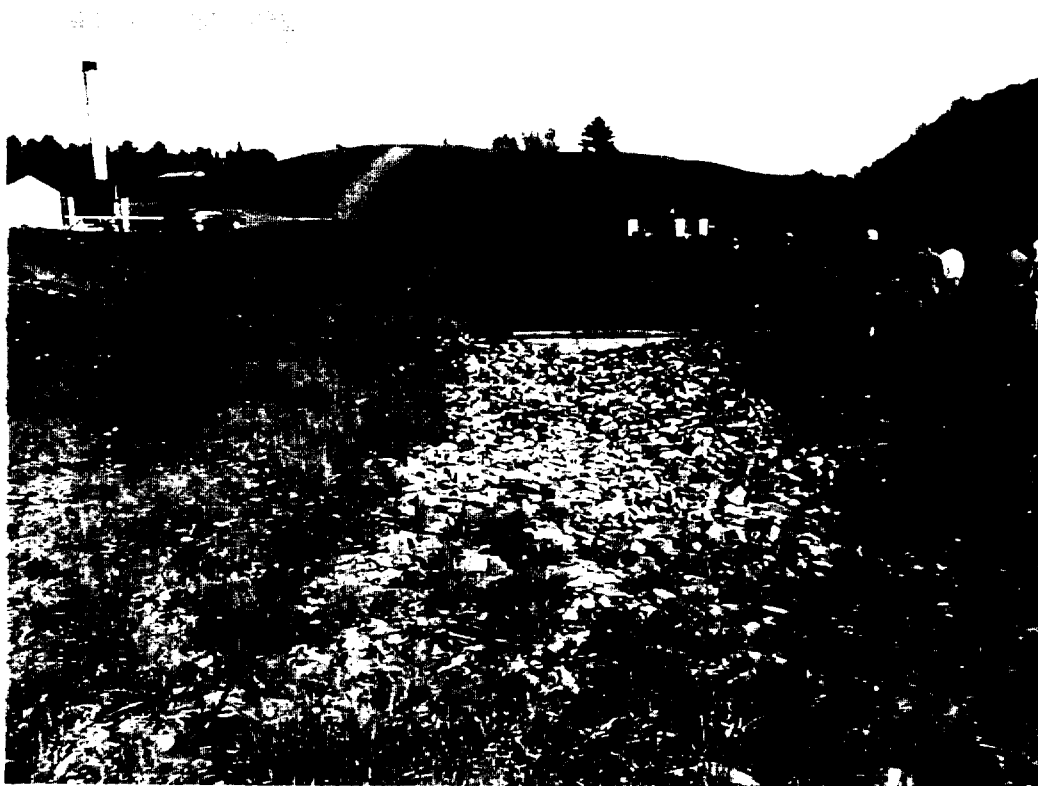
Photo 14 Top of Rip Rap Downcomer – South Sidewall of Sedimentation Basin.

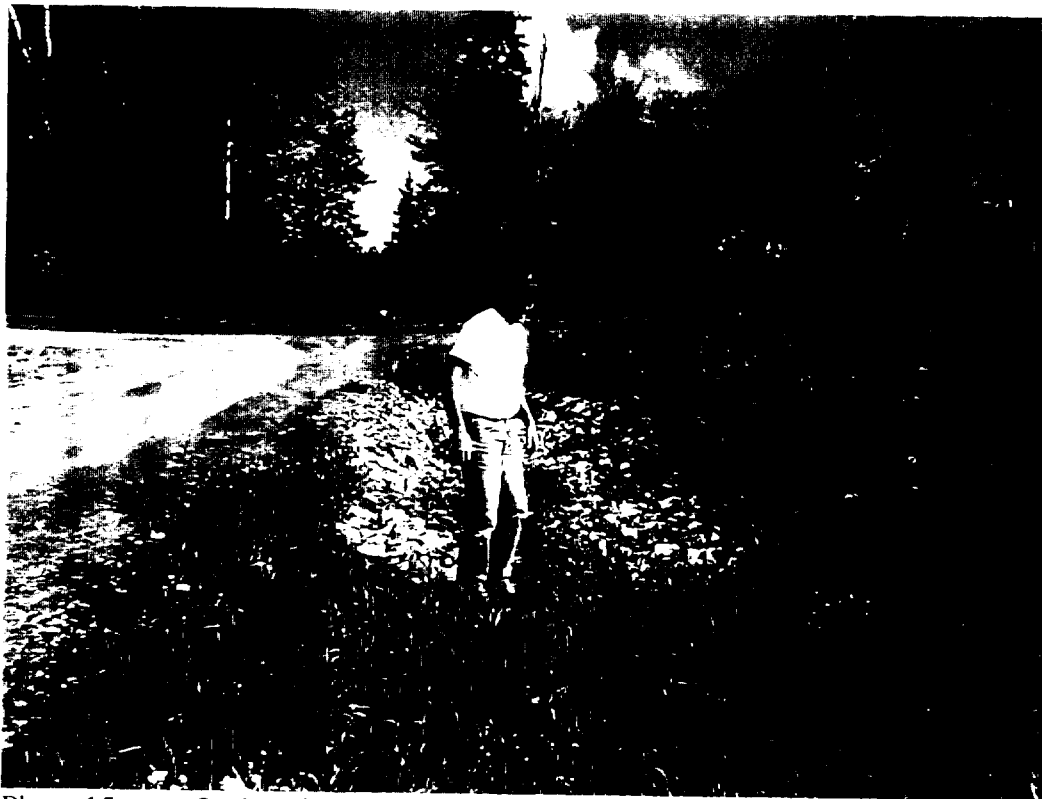
The perimeter ditches were in good condition with no signs of erosion, sedimentation, or blockage (Photo 15).

Photo 15      Outlet of Culvert No. 3.

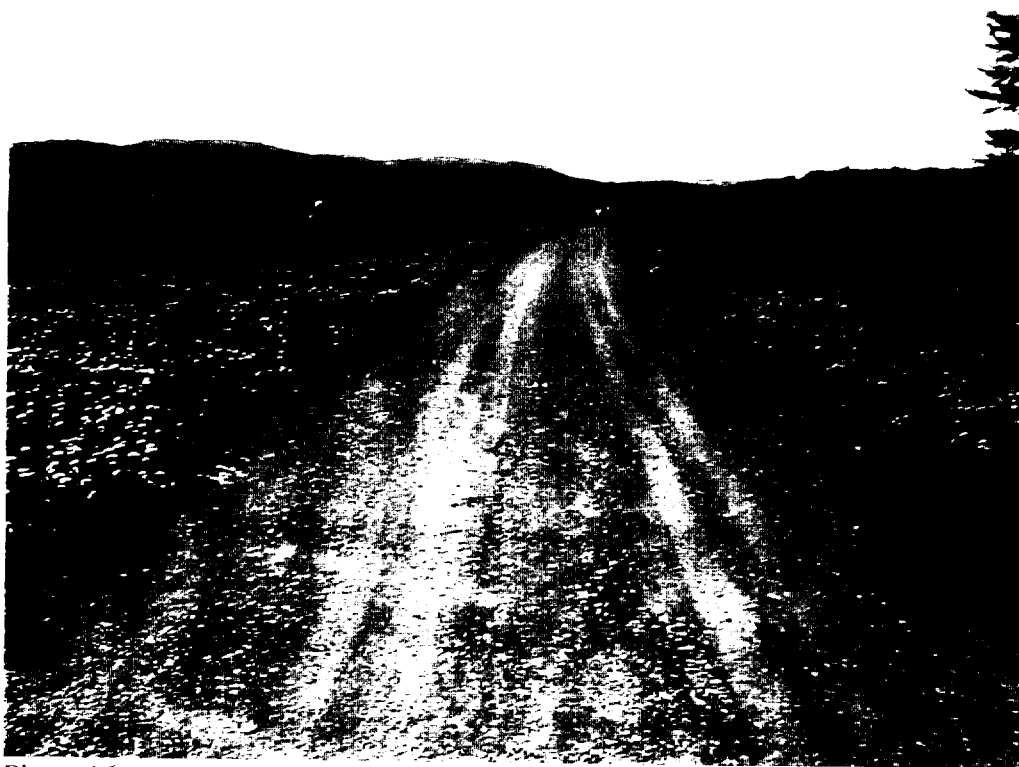
The perimeter and access roads of the SWDA were in good condition (Photo 16). Erosion was observed in the access road leading from the SWDA to the IWS-3 cap (Photo 17). The erosion should be repaired to maintain access to the IWS-3 area for maintenance.

Photo 16      Access Road at Top of Landfill.

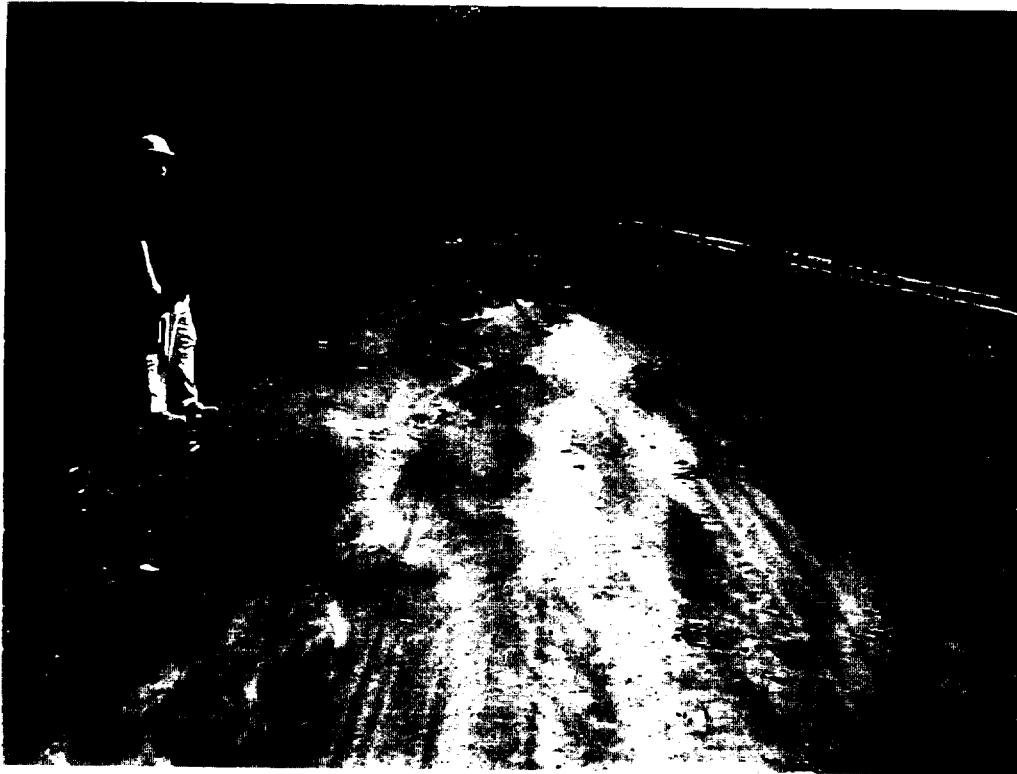
Photo 17      Erosion in Access Road to IWS-3.
